GEOTECHNICAL RECONNAISSANCE OF THE 2010 DARFIELD (NEW ZEALAND) EARTHQUAKE

Version 1: 10 November 2010

EDITORS

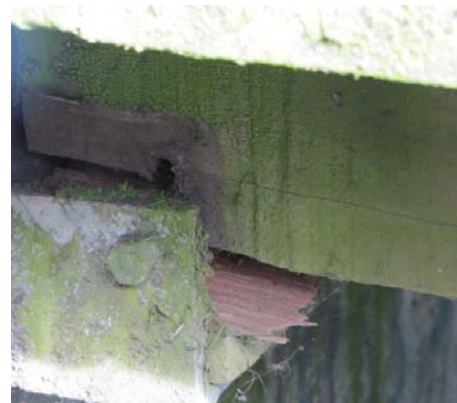
b) Sheared bearing on east bank

Figure 7.16 Footbridge on the Avon River near Medway Road

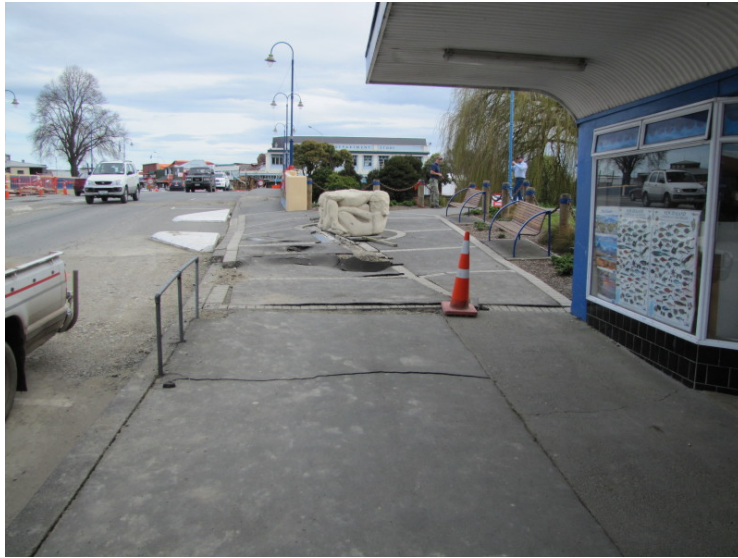
Figure 7.17 Cracking of east approach roadway, Williams Road Bridge

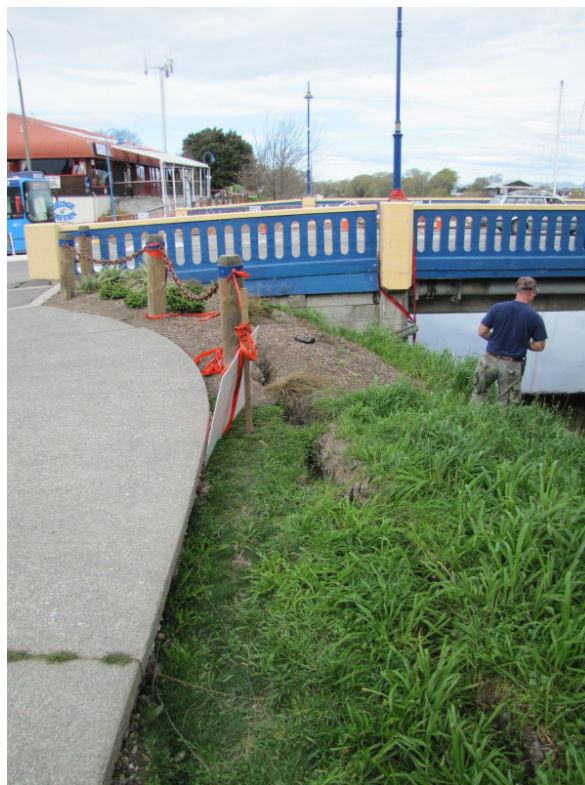
Figure 7.18 Incipient lateral spreading of east abutment, Williams Road Bridge

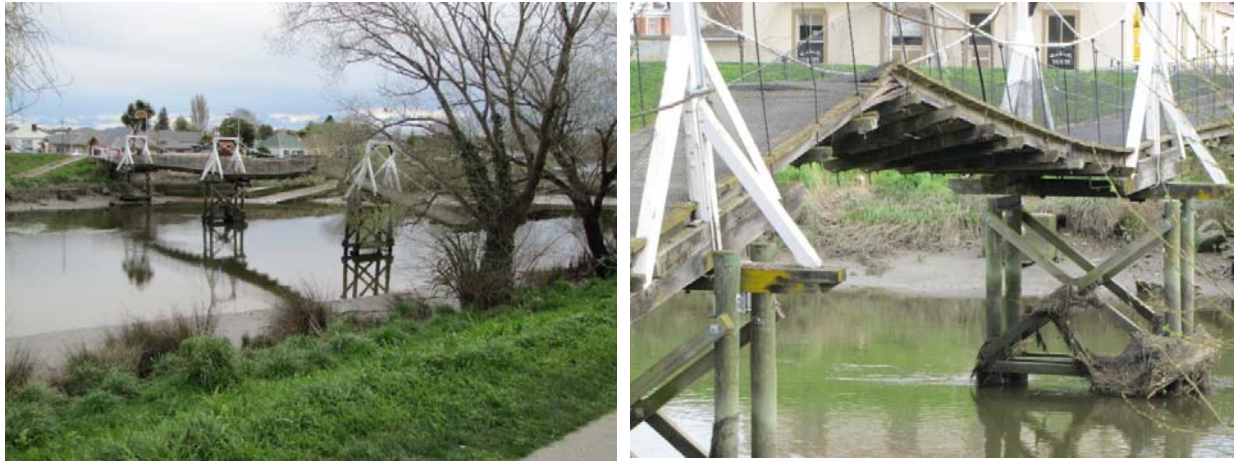
Figure 7.19 Buckling of footbridge near Trousselot Park

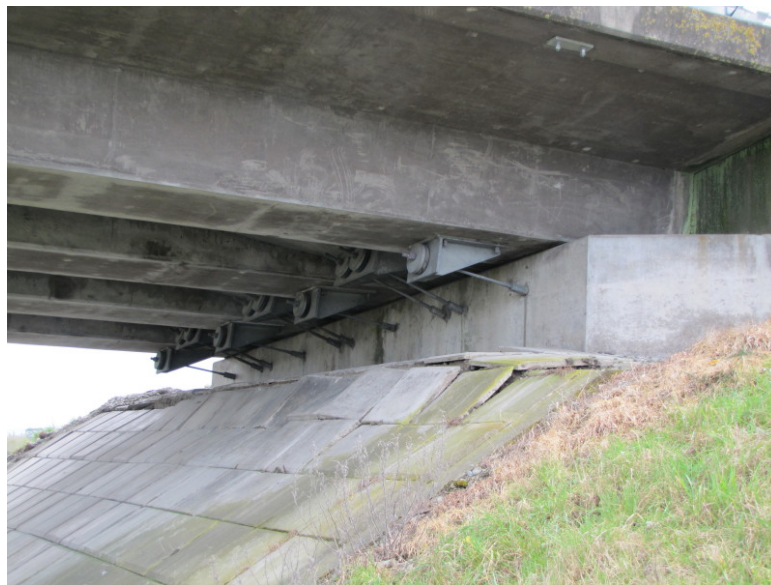
Figure 7.22 Cable Restrainers at north abutment, Chaney's Overpass

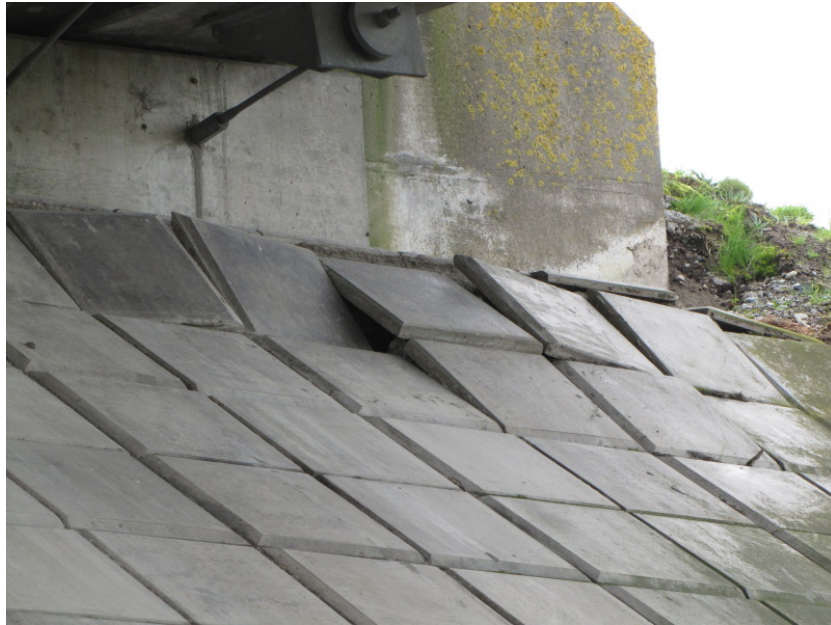
Figure 7.23 Displaced concrete tiles on end embankment for north abutment, Chaney's Overpass

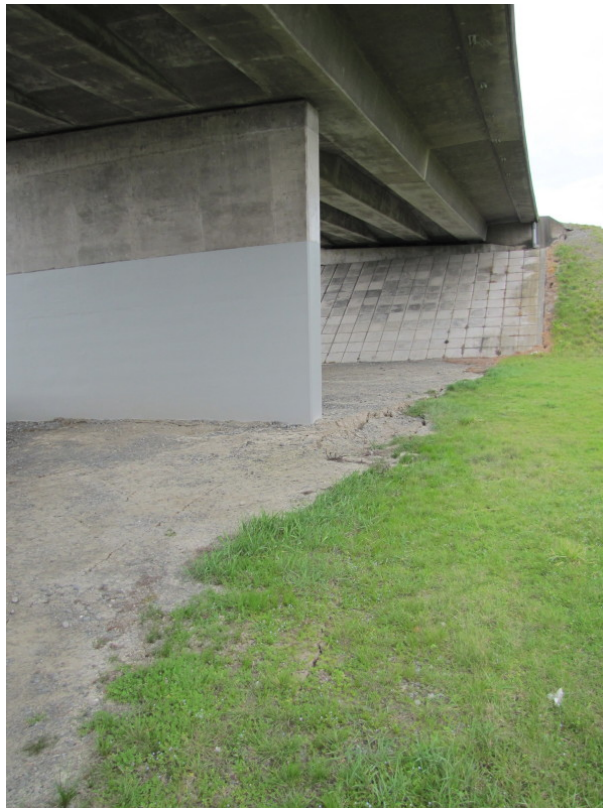
Figure 7.24 Evidence of liquefaction beneath Chaney's Overpass

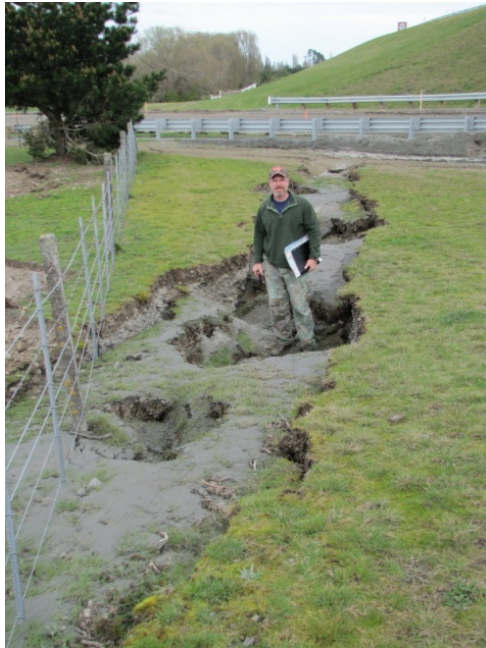
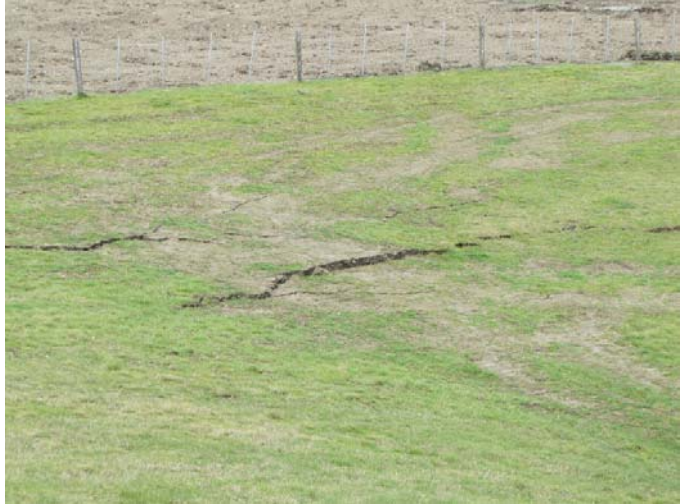
Figure 7.25 Evidence of liquefaction adjacent to Chaneys Overpass

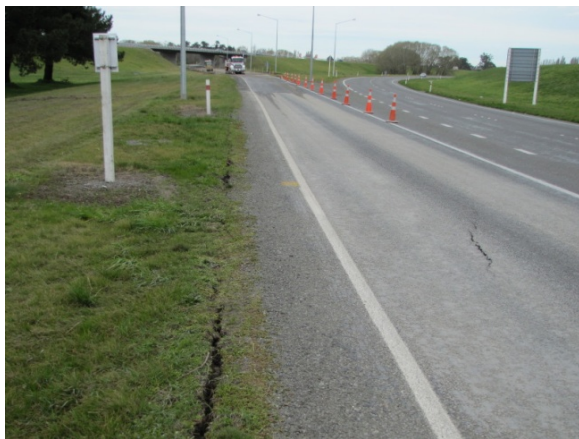
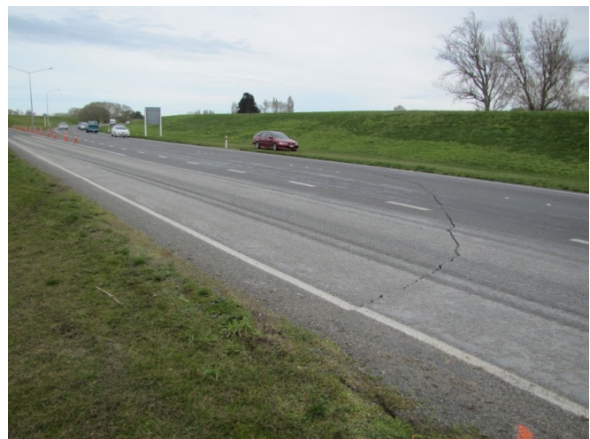
Figure 7.26 Cracking in and along roadway adjacent to Chaneys Overpass

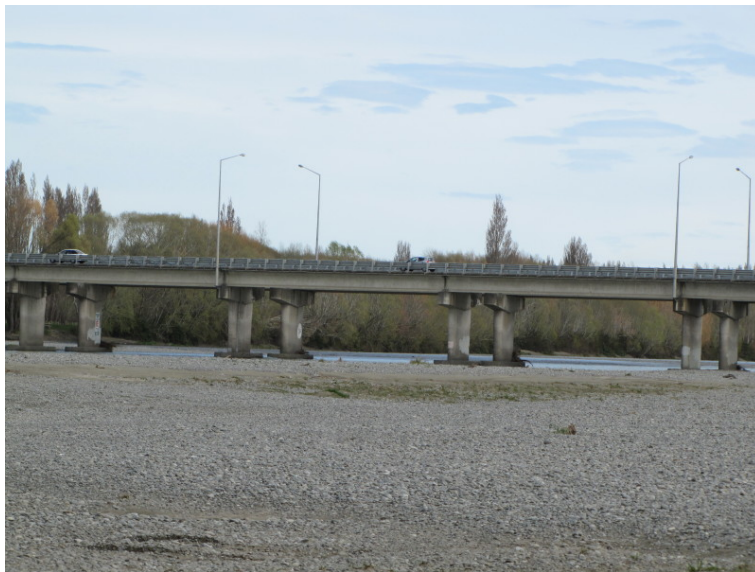
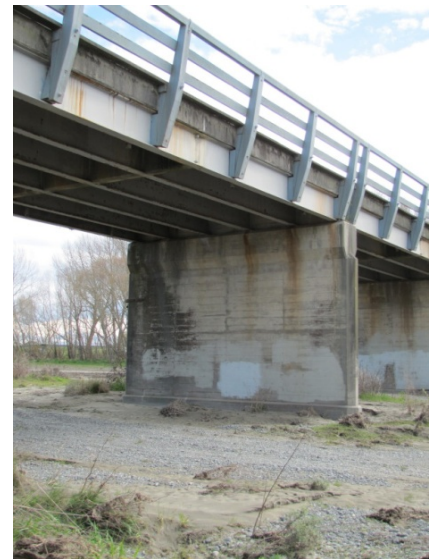
The NZ-GEER reconnaissance team also inspected the two main spans for the Highway 1 crossing of the Waimakariri River (43.4153°S, 172.6467°E) (Figure 7.28) and the adjacent railroad bridge (43.4128°S, 172.6508°E). While there was some evidence of liquefaction adjacent to several of the piers for the east span of the Highway 1 crossing (Figure 7.29), there was no indication of displacement of the foundation piers or structural damage to the bridge.

Figure 7.28 Highway bridge across the Waimakariri River

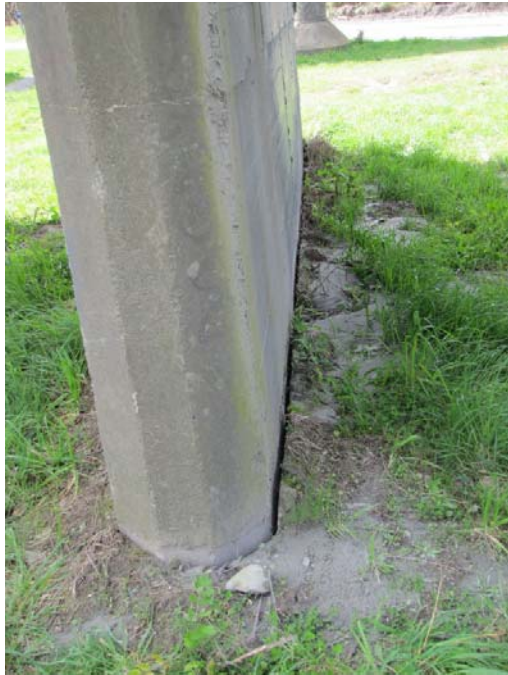
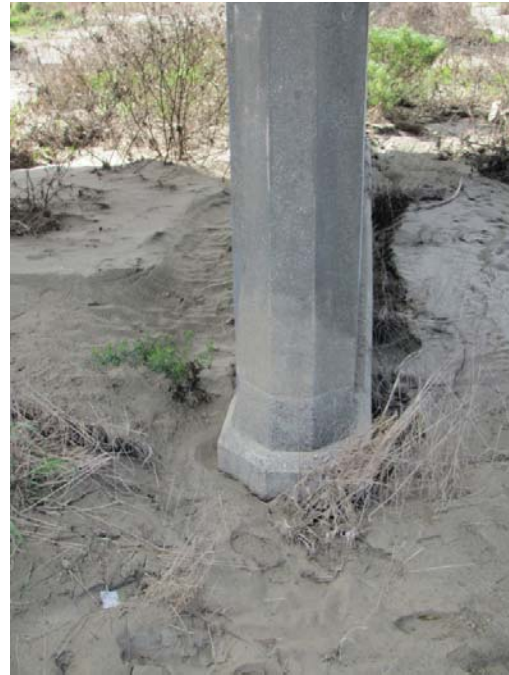
Figure 7.29 Evidence of liquefaction at Highway 1 bridge piers on the north side of the Waimakariri River

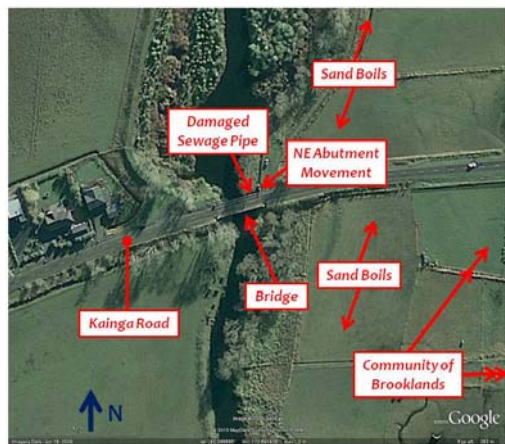
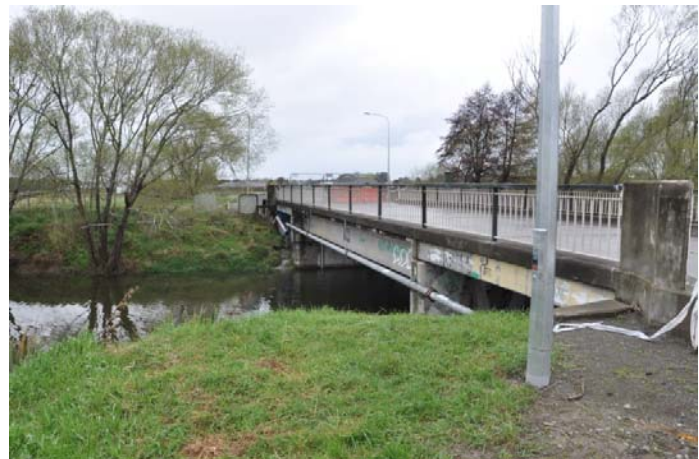
The Kainga Road Bridge is a short span bridge leading to the Brooklands residential community (Figure 7.30), and according to the New Zealand Natural Hazard Platform Bridge Research Group, the bridge remained closed at the time of the Team's visit on 13 September 2010 at the request of local authorities to limit access to an adjacent area extensively damaged by liquefaction. Structurally, the 1963 mixed girder-slab reinforced concrete bridge was in good condition. However, movement of the northeast abutment wing wall resulted in damage to an 18-cm diameter sewage pipe that was rigidly connected along the bridge span (Figure 7.31). Raw sewage continued to flow into the river from the damaged pipe at the time of the site visit (Figure 7.32a). Posted signs and discussions with locals confirmed that the flow was contaminated liquid (Figure 7.32b). Directly below the bridge, a pipe of similar diameter suffered no damage, and the team noted that its support to the abutment wall was filled with flexible foam (Figure 7.33). At the East abutment, the northern wing wall moved towards the river and developed a gap with its backfill soils of about 2 cm, whereas the southern wing wall appeared to remain fixed. Soil spread away from the east abutment south wing wall leaving a gap of about 4 – 6 cm at its toe. Surrounding low lying marshlands and old paddock fields (as indicated by a postal worker interviewed during our visit) showed evidence of liquefaction (Figure 7.34).

Figure 7.30 Kainga Road Bridge to the Brooklands residential community (a) GoogleEarth image (43.3998°S, 172.6910°E) and (b) overview of bridge looking west (43.3997°S, 172.6916°E).

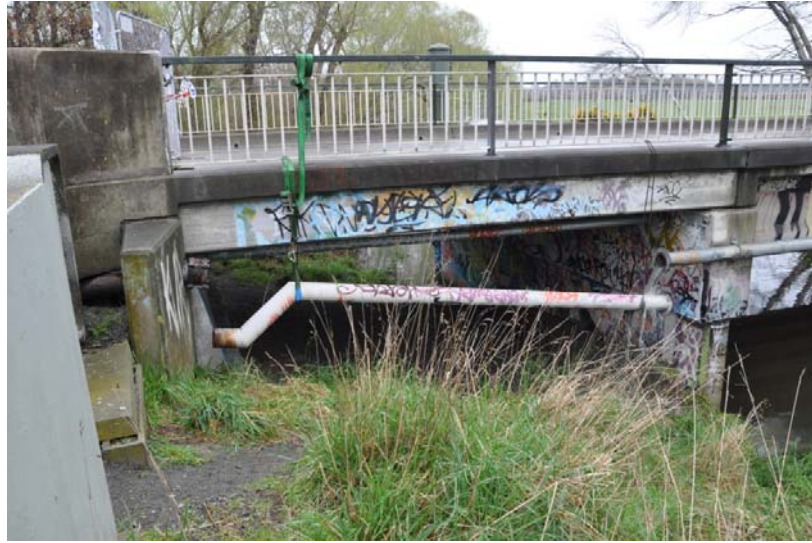
Figure 7.31 Damage to sewage pipe at the Kainga Road Bridge (43.3997°S, 172.6916°E)

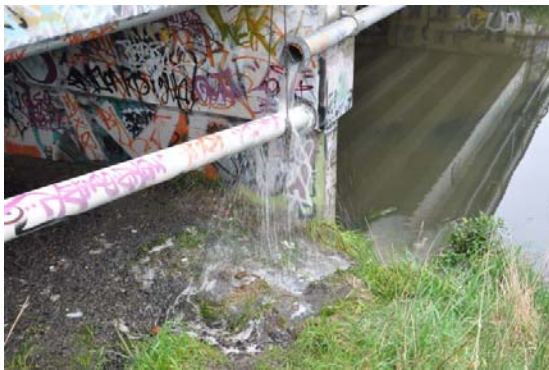
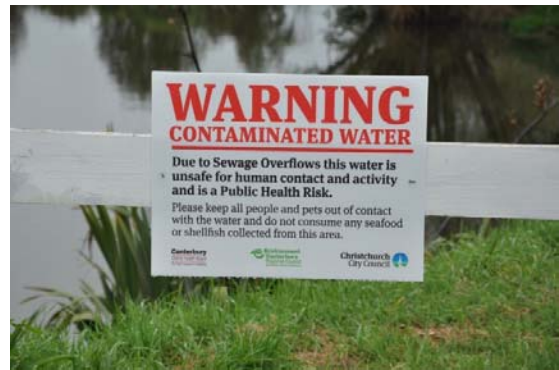
Figure 7.32 Outflow from damaged pipe at Kainga Road Bridge and surrounding warnings to the community (43.3997°S, 172.6916°E).

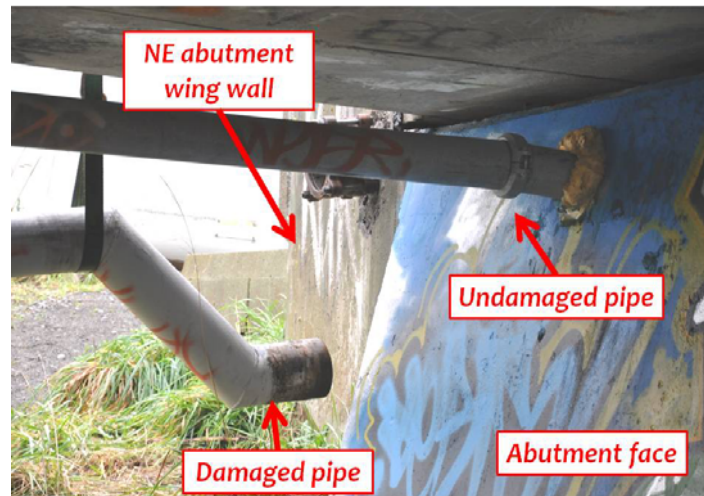
Figure 7.33 Below the East end of the Kainga road bridge (looking northeast). (43.3998°S, 172.6914°E).

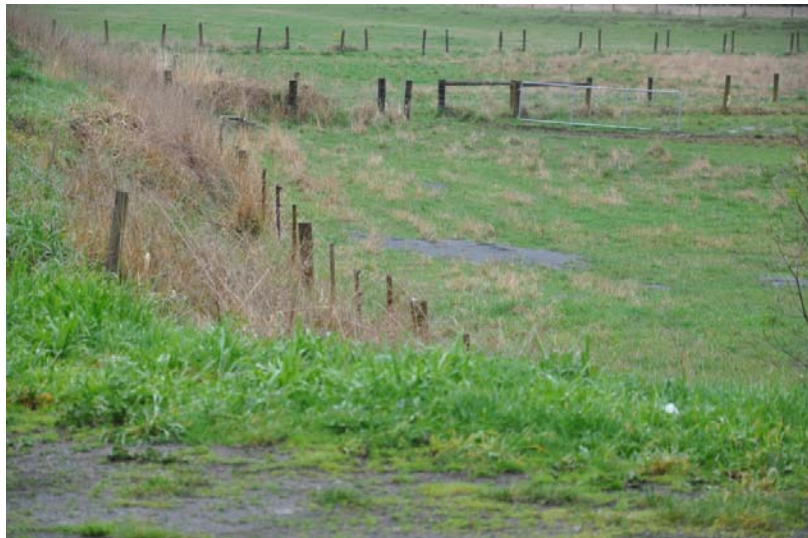
Figure 7.34 Evidence of liquefaction in surrounding low lying marshlands on the east side of the Kainga road bridge (43.3995°S, 172.6917°E).

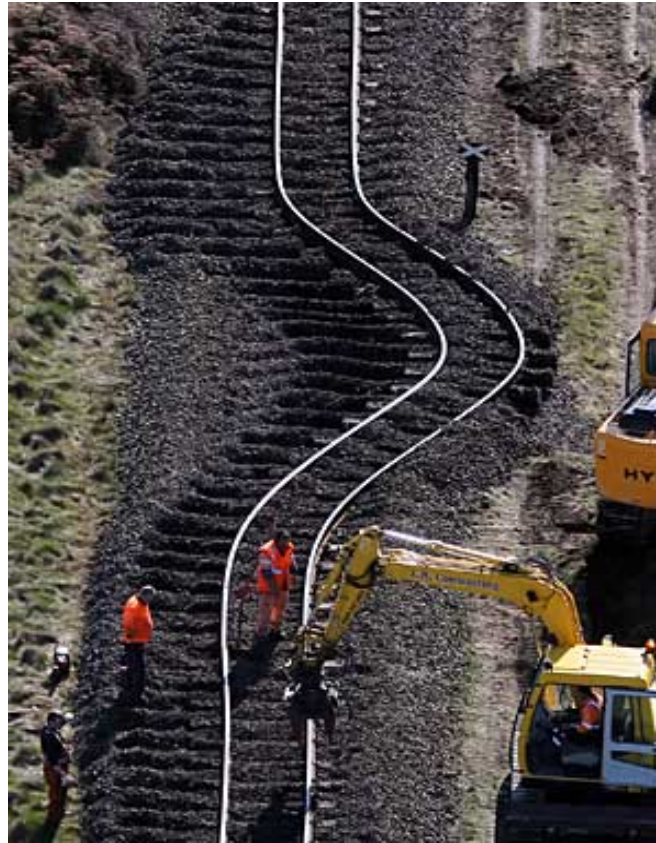
Damage to railways embankments was reported by members of the New Zealand reconnaissance team near Rolleston (Figure 7.35) and Woodward Glenn, just south of Kaiapoi (Figure 7.36). In the latter case, the damage appeared due to liquefaction-induced lateral spreading. By the time the team arrived in Rolleston (13 days after the earthquake), the damage to the tracks had been repaired. The Team was informed that the damaged rail line at Rolleston was fixed the day of or the day after the earthquake and that the slumping rail lines at Woodford Glen had been repaired 4 days after the earthquake.

Figure 7.35 Railway Embankment at Rolleston (photo by I. McGregor)

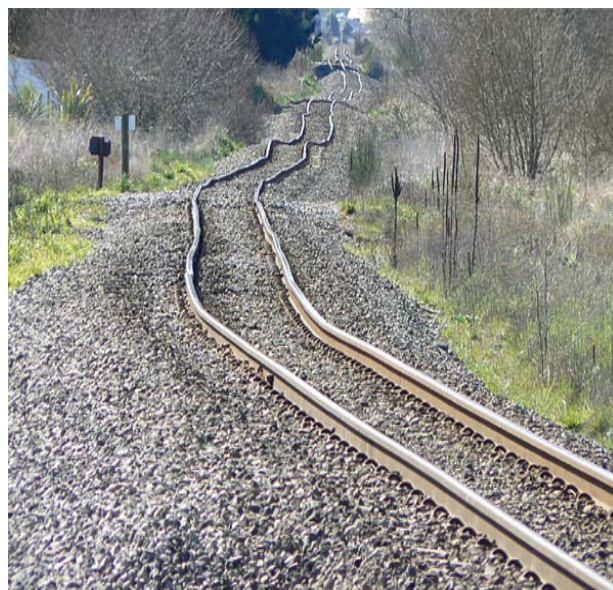
Figure 7.36 Damage to rail line at Woodford Glen (photo by L. Matthews and J. Overend)

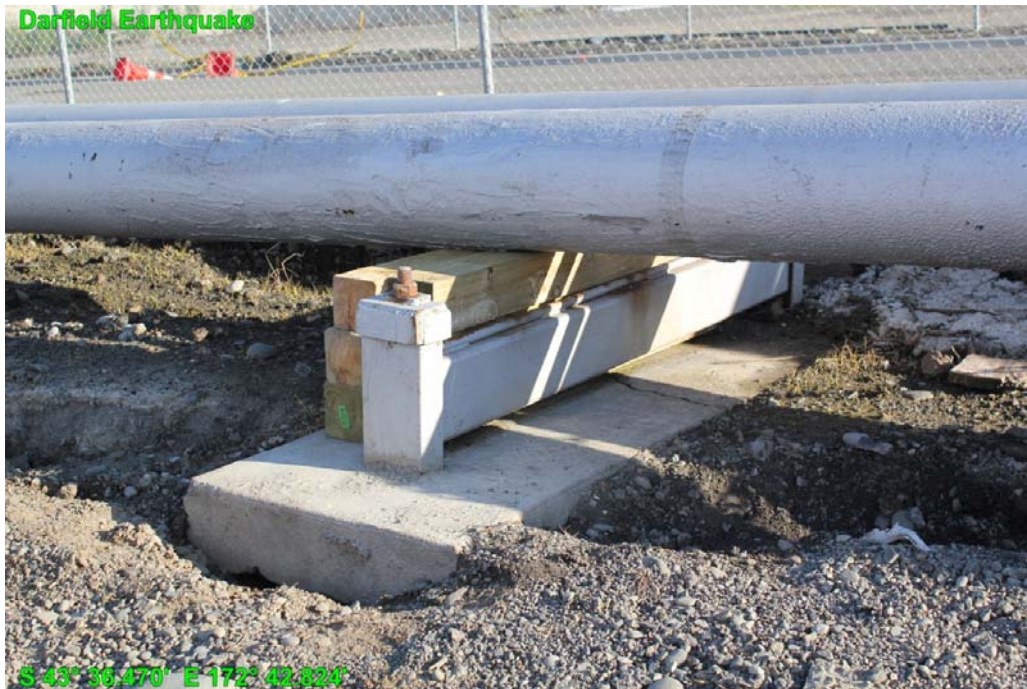
All the wharves underwent limited settlement and lateral deformation, though limited to 0.2 to 0.3 m. Typical damage from settlement and lateral deformation are shown in Figures 7.37-7.39 .

Figure 7.38 Temporary wooden support to accommodate settlement under fuel line (43.60783°S, 172.71373°E)

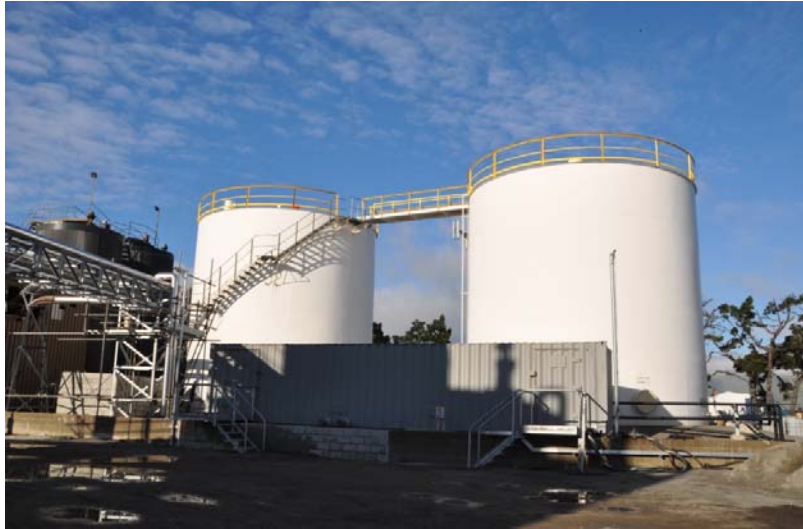
As a result of the lateral spreading, as well as liquefaction within the bitumen plant, four tanks and some supporting piping suffered movement and damage. The most severe lateral movement was that of Tank 1 (located at 43.6085°S, 172.7149°E), which moved laterally 50 mm towards the water. Tank 2 (43.608768°S, 172.714651°E) settled uniformly about 30 mm causing separation of the connecting bridge between it and a neighbouring tank of like geometry (Figure 7.42). This tank, with dimensions of 12.8 m high by 13 m diameter, housed used oil and was nearly filled to capacity at the time of the main shock, weighing an estimated 550 tons. Tanks 3 and 4 (43.6085°S, 172.7149°E) were side-by-side and each experienced movement that resulted in pullout of nearly all perimeter anchor bolts at their base. These tanks were 12.5 m tall by 6 m diameter with an estimated 150 ton weight at the time of the main shock. Crews were repairing the support anchorage for Tanks 3 and 4 with the retrofit shown in Figure 7.43. No structural damage to the tanks was observed and flexible connections survived the strong shaking with only minor leakage. Asphalt repair using cement injection to fill the lateral spread cracks was ongoing during the teams visit (Figure 7.44). Sand boils were also observed at several locations within the plants boundaries. Soil samples of the ejecta indicated the material was clean sand with little to no fines (Figure 7.45).

Figure 7.42 Tank 2 (right most large white tank) with Tanks 3 and 4 shown to the left (smaller grey tanks) at the Fulton Hogan Bitumen Plant (43.6088°S, 172.7147°E).

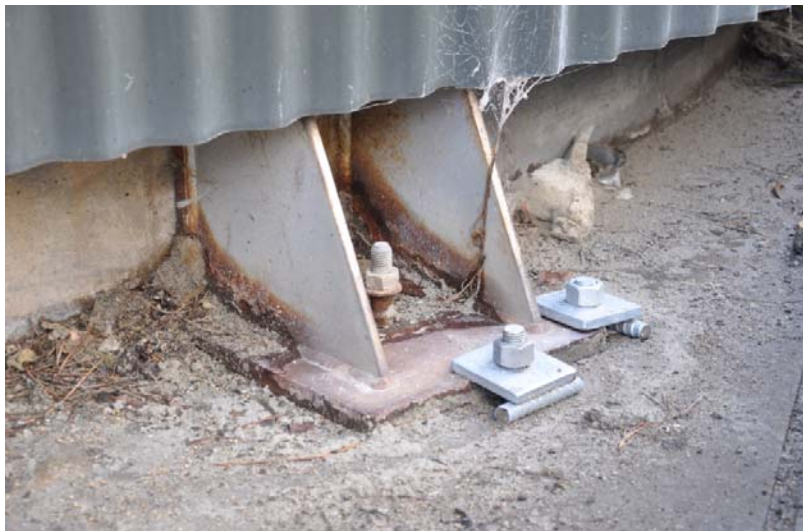
Figure 7.43 Typical repair to Tank 3 and 4 (addition of clamp plates). Note the pullout of the original anchorage. Fulton Hogan Bitumen Plant (43.6085°S, 172.7149°E).

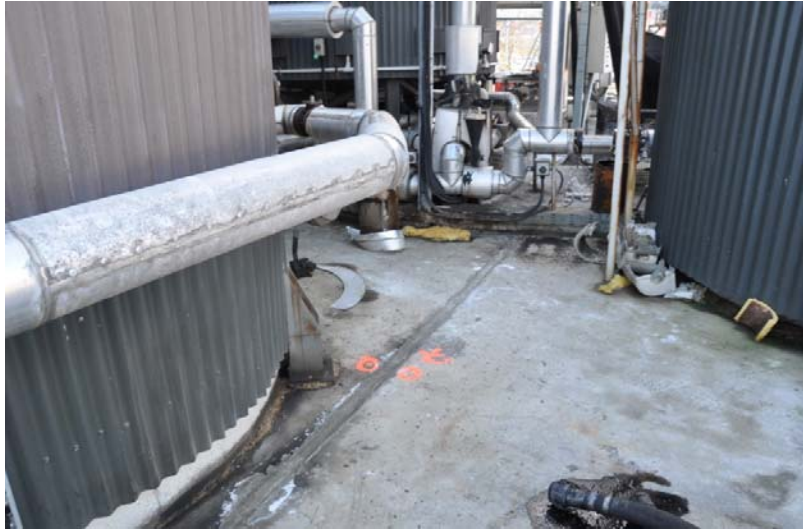
Figure 7.44 Repair of lateral spread cracks within the Fulton Hogan Bitumen Plant, nearby Tank 3. (43.6085°S, 172.7150°E).

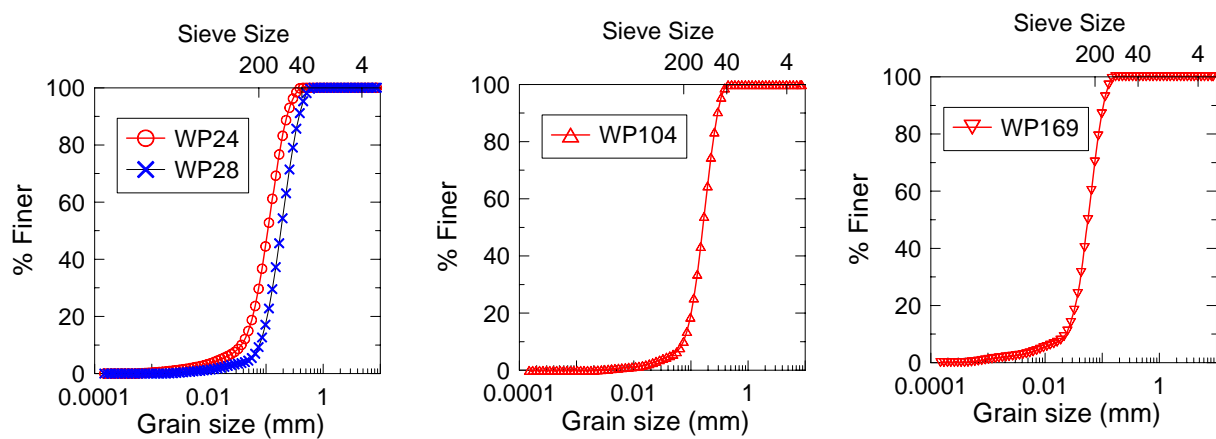
Figure 7.45 Laser diffraction tests of samples taken from ejecta observed at the Fulton Hogan Bitumen Plant. Sample WP169 taken at 43.6087°S, 172.7142°E.

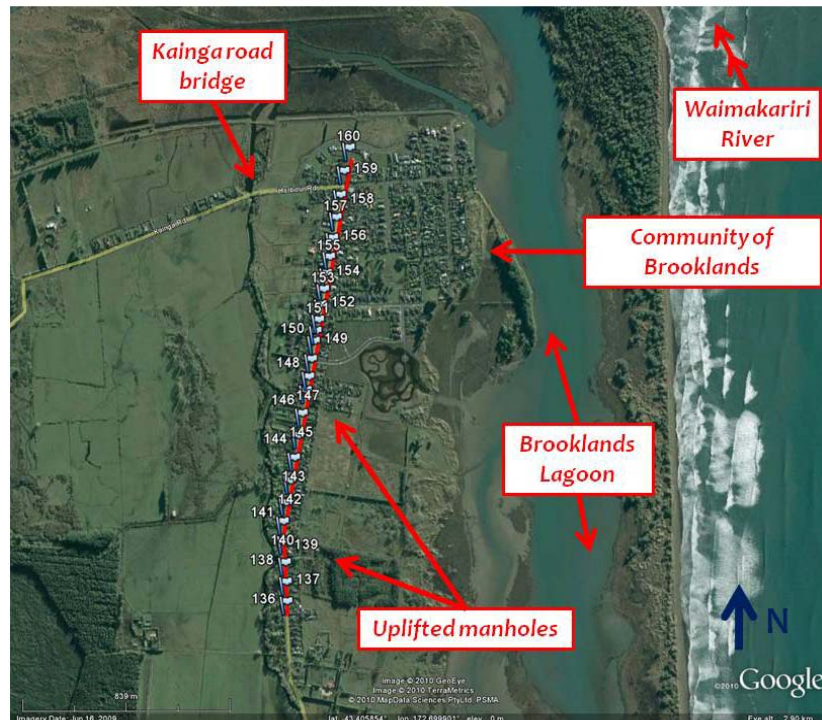
In a number of residential communities, sewage and potable water were problematic immediately following the main shock. Perhaps hardest hit were the communities of Spencerville and Brooklands. At the time of the Teams visit on 13 September 2010, neither community had a functioning wastewater collection system, and Brooklands did not have potable water. Liquefaction along Lower Styx road, the primary connection between these two communities, caused ground subsidence, a rise in the water table, and uplifting of 25 manholes (Figure 7.46). Construction workers were dewatering the region during the Team's visit and informed us that the manholes were 4 m deep. The manholes were approximately 28-46 cm above the existing road surface (Figure 7.47).

Figure 7.46 Approximately 2km stretch along Lower Styx Road with observed uplifted manholes. (GoogleEarth image; 43.4059°S, 172.6999°E). Waypoints 136-160 represent locations of elevated manholes.

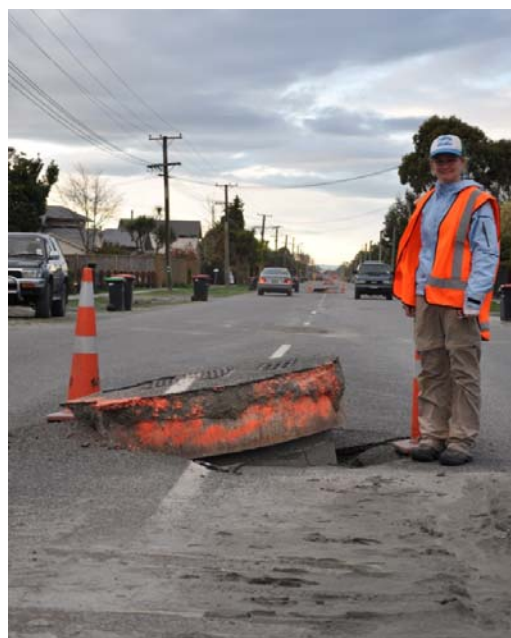
Figure 7.47 Uplifted manholes along Lower Styx Road, note the continuation of pattern in the foreground (43.4113°S, 172.6930°E).
